Implementation Guidance for the Control of Undesirable Vegetation on Dredged Material

PURPOSE: The purpose of this technical note is to provide guidance for implementing selected management practices to control undesirable vegetation on dredged material.

Lee, C. R. (2000) "Implementation guidance for the control of undesirable vegetation on dredged material," *DOER Technical Notes Collection* (ERDC TN-DOER-C20), U.S. Army Engineer Research and Development Center, Vicksburg, MS.
www.wes.army.mil/DOTS/DOER/

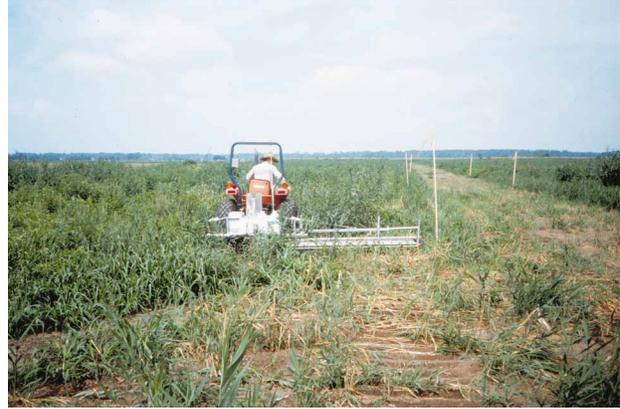
Figure 26. Wiper applying Round-Up® herbicide at a rate of 2.3×10^2 ml/ha (32 oz/acre) adjacent to Plot 1 at Eagle Island CDF, NC (23 May 00)

was sought to manage the plant tops. After 6 months, the compost was used as cellulose in a manufactured topsoil according to RSMT. On May 23, 2000, the new regrowth of the Phragmites was wiped with a wiper panel on two separate demonstration plots (each 6 by 30 m (20 by 100 ft)) with the glyphosate herbicide Round-Up® at a rate of 2.3×10^2 ml/ha (32 oz/acre) once (Figures 24-27) and then a second time after 4 days. Two similar size control (untreated) plots were established for comparison. The plant height was approximately 0.6 m (2 ft) high each time wiping was performed. Effects of the wiping were observed on 24 Jun 2000 (32 days) (Figures 28 and 29). On 5 Jul 2000 (44 days), some new regrowth was observed (Figures 30 and 31). A gallon of ready-to-use Round-Up® was applied by hand spray to spot-spray the green leaves present on each demonstration plot. The concentration of glyphosate was 0.96 percent as the isopropylamine salt. Observations (Figures 32 and 33) were made on 22 Jul 2000 (60 days after the initial wiping and 14 days after hand spot-spray application). Control plots that were not wiped with herbicide were covered with Phragmites and other undesirable weeds (Figures 34 and 35). It is expected that the roots/rhizomes of Phragmites in these plots will be dead allowing material from that area to be used for RSMT manufactured topsoil or other uses without the interferences caused by Phragmites.

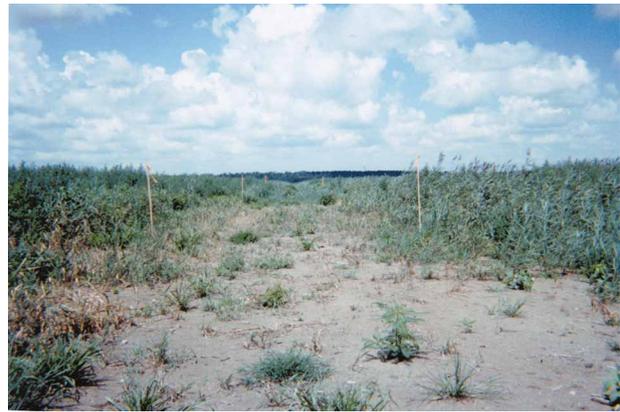
Figure 28. Observation at 32 days of the herbicide-wiped Plot 1 in the foreground with the unwiped control in the background (24 Jun 00)

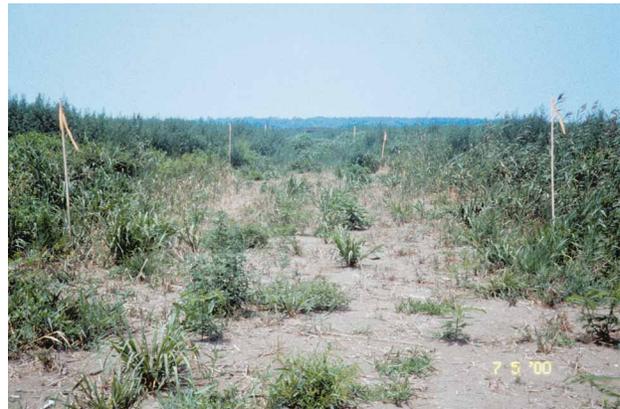
Figure 30. Observation at 43 days of the herbicide-wiped Plot 1 in the foreground with the unwiped control in the background (5 Jul 00)
